USDA Hurricane Mitch Recovery Program

Damaged Rural Watersheds Rehabilitated through Strengthened Local Capacity.

SECTION II: DETAILED ACTIVITIES BY COUNTRY

A. Country Program Description—Honduras

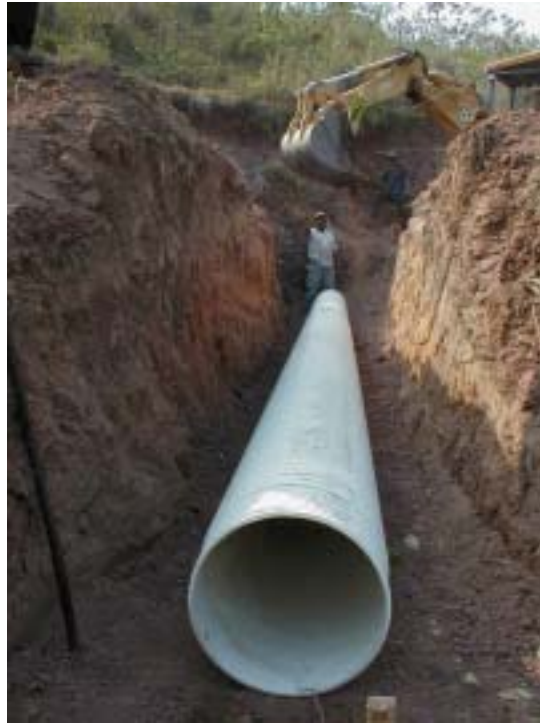
Through installation of improved drainage structures, and correction of soil erosion and water runoff problems, 163 road exigencies were eliminated, and 43.8 kilometers of rural farm-to-market roads in were rehabilitated. Specific road exigencies included sites of poor road drainage resulting in serious soil erosion, washouts, undercutting of land supporting bridges, landslides, and serious sedimentation of waterways. These exigencies were both sites of damage and causes of damage as well, as they continued to serve as major producers of sediment and excessive water runoff ultimately affecting other locations. Local communities and USDA technical specialists agreed that these particular areas posed threats to life and/or property and were critical for action. HMRP activities included the installation of 59 culverts (figure 2), as well as numerous dips, fords, and other interventions, undertaken with full community involvement.

Figure 2. Culvert being placed to improve road drainage and prevent damaging water runoff

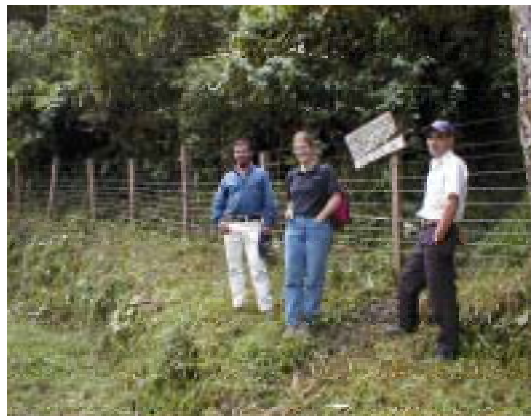
Seventy-eight hectares of water sources were protected by fencing in selected areas of the Humuya micro-watersheds; the work resulted in greater protection of communities' potable water from sediment and contamination. Local communities in the Humuya rated as highest priority the protection of the micro-watersheds that produce their potable water. Erecting fences around water sources (figure 3) provides a barrier to farm expansion into the areas of forest buffer that help keep water sources free of sediment and microbial and agrichemical contamination in runoff from farms.

Figure 3. Fenced water source

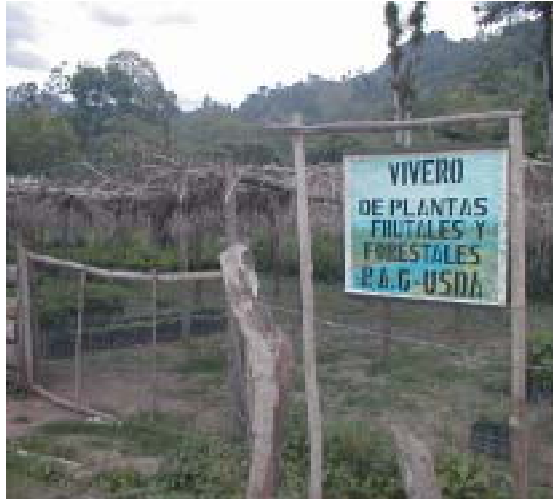
Figure 4: Tree nursery established by Proyecto Aldea Global through a grant from USDA

621 hectares of critical areas in targeted micro-watersheds were reforested with 217,175 trees helping to stabilize slopes, establish trees on degraded lands, and reduce vulnerability to future storms. USDA promoted reforestation by providing several vital services: targeted grants to NGO partners, technical guidance, and coordination of tree planting. Grants to Fundación Banhcafe and Proyecto Aldea Global (PAG) for nurseries and reforestation totaled \$63,204. Fundación Banhcafe established 40 small nurseries, while PAG established 4 large nurseries of 12,500 seedlings each (figure 4).

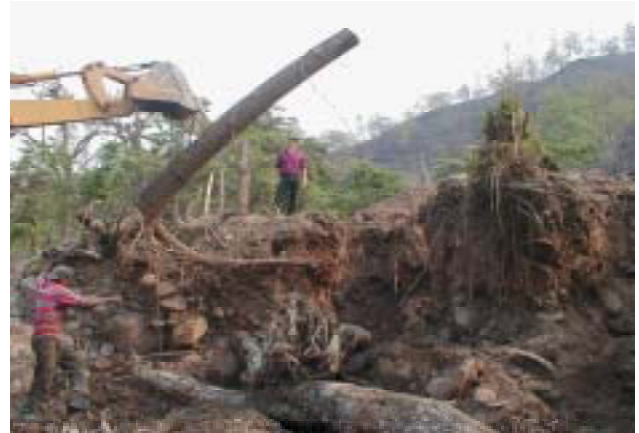
A total of 8 km of streams were rehabilitated by stabilizing damaged stream banks through the use of bio-engineering techniques and planting of vegetation. Unstable stream banks cause new damage in other locations because they serve as sources of sediment into the stream and may allow stream water to flood into agricultural areas, eroding farmland. Bio-engineering is the innovative use of primarily natural materials such as logs, boulders, and soil, to rebuild, strengthen, and stabilize damaged banks. Often, after vegetation grows back over the newly fortified banks, it is not readily apparent that any repair was ever done. The following diagram and photo illustrate the use of bio-engineering technology.

Figure 6. Photo of bio-engineering work on one of the stream banks in diagram

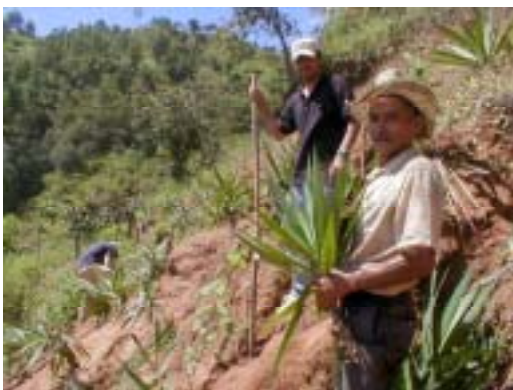
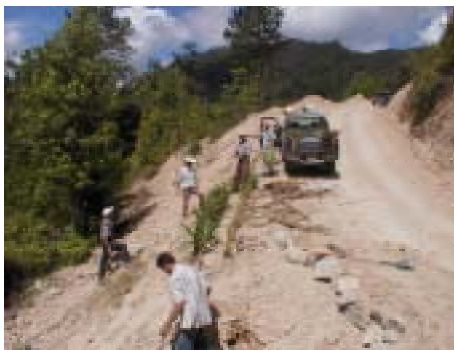
Without stabilization, landslides would have continued depositing sediment into the streams, especially during storm events. USDA implemented vegetative planting of the landslide sites utilizing volunteers from the Honduras Conservation Corps (Cuerpos de Conservacion Honduras), a conservation NGO comprised of youth from around Honduras.

Figures 7-8. Hillside stabilization

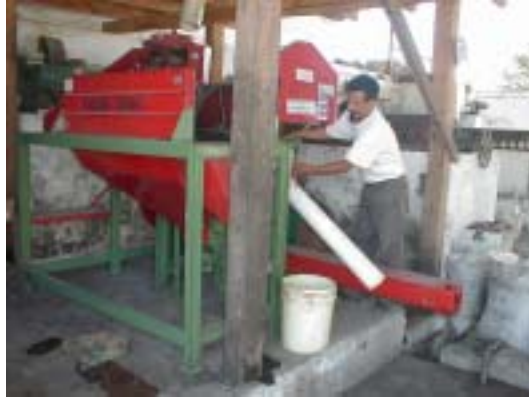
Through the use of new coffee de-pulping technology, significant reductions in water pollution from coffee processing were achieved (estimated reduction of 646,800 liters of polluted water from three sub-watersheds). Coffee is the main agricultural crop in the upper Humuya watershed, and processing of the coffee fruit after harvest to remove the pulp is a source of water pollution in the area. In the "wet processing" method, the coffee pulp is discarded directly into the stream. Pollution results from the dumping of large amounts of organic material into the water; pesticides on the pulp itself add to the pollution. USDA provided an innovative "dry processing" machine to COCALAL, a progressive coffee cooperative in Las Lajas in the upper Humuya. The dry processing machine uses minimum amounts of water, and the coffee pulp waste it ejects may be composted and decomposed with red worms and then used as a fertilizer.

Figure 9. “dry processing” machine

The use of the dry processing machine in last year’s harvest prevented pollution of an estimated 646,800 liters of water. Coffee (with shade trees) is a very suitable crop for the upper Humuya watershed, and desirable for watershed protection since it provides much more vegetative cover to the ground than other crops. In addition to introducing the “dry processing alternative”, USDA also provided COCOLAL technical assistance in seeking “eco-friendly” or “organic” certification for their coffee. The hope is that if higher returns are gained for dry processed coffee, other Humuya farmers will want to use this process as well.

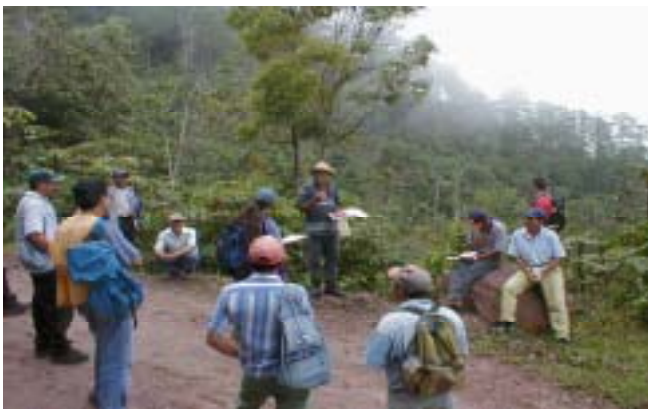
Figure 10 . Training in doing participatory watershed mapping

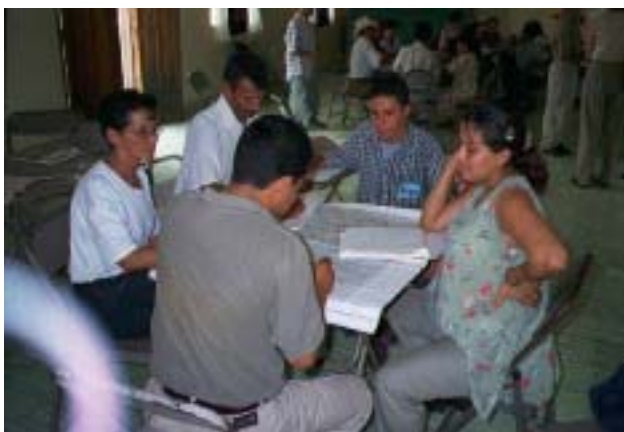
Figure 11. Participants conferring at workshop to identify problems in their watershed

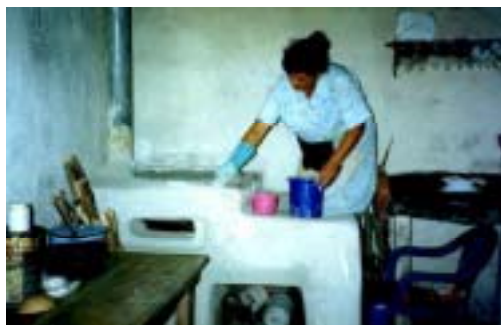
Figure 12. New improved stove with owner

The stoves, locally manufactured, reportedly use only half as much wood as the stoves they replaced, and have the added benefit of a chimney which draws the smoke out of the

house. The improved stove technology is already showing promise; an undetermined number of additional households have installed the fuel-efficient model after seeing its benefits, including a hotter cooking fire. USDA's support for this activity included a grant of \$50,884 to PAG and \$3,695 to Fundacion Banhcafe for stove manufacture and installation.

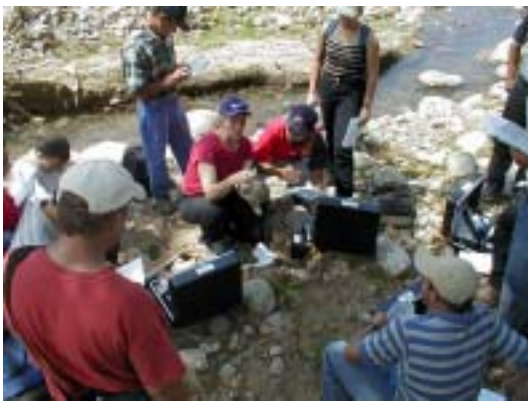
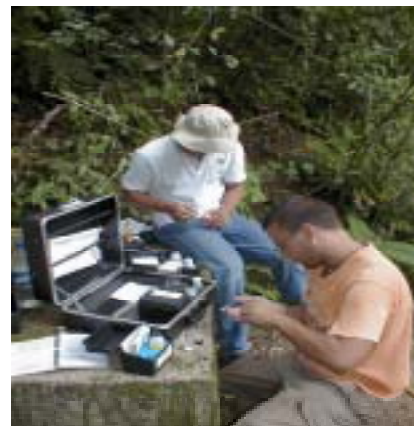
Figures 13-14. USDA conducts field training in water testing.

USDA provided a grant to Fundacion Banhcafe for \$3,630 for water testing in the Humuya. USDA also provided water-testing equipment and intensive training in its use. In the second year of the project, 171 water samples were taken. This water quality monitoring has allowed communities to realize first-hand the negative effects of some current practices on the quality of their watershed. An additional years' supply of chemicals for the testing kits was provided so that communities can continue monitoring beyond the life of the project.

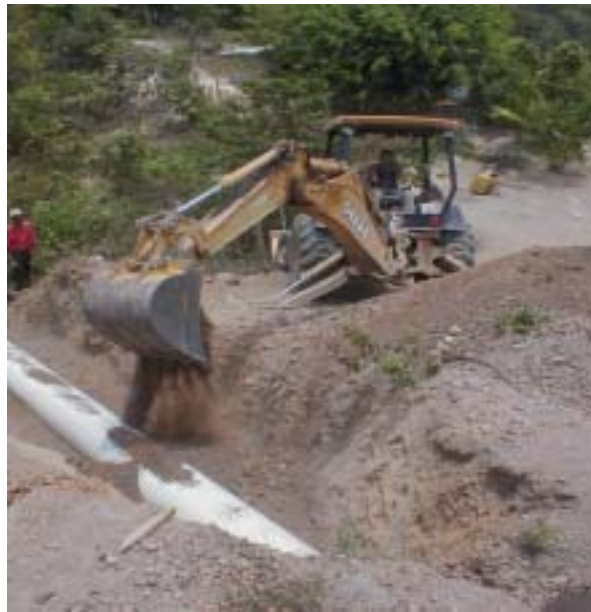
Through their partnership with USDA, Fondo Cafetero Nacional and local communities learn new and better ways to maintain roads to prevent erosion and landslides due to storms. Fondo Cafetero Nacional (FCN) is the Honduran agency with responsibility for maintaining secondary farm-to-market roads in coffee growing areas (including the Humuya watershed). USDA partnered with FCN to implement repair of some of the roads and to provide them with improved technical approaches on the sizing and placing of culverts.

Figure 15. Farm-to-market road repair in the Humuya upper watershed

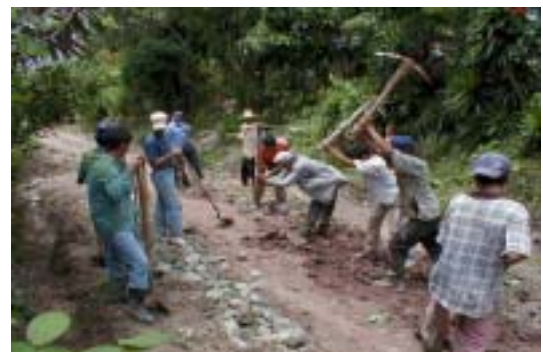
Agreements were made with each of the four municipalities covering the Humuya upper watershed; USDA provided materials (such as culvert tubs) and technical expertise; FCN provided heavy machinery and staff; and the communities attended road maintenance training and formed maintenance committees. Through the partnership, USDA fostered a commitment from local communities to help maintain the rehabilitated roads in the future.

Figure 16. Community members using hand labor to practice simple but effective road drainage improvement techniques.

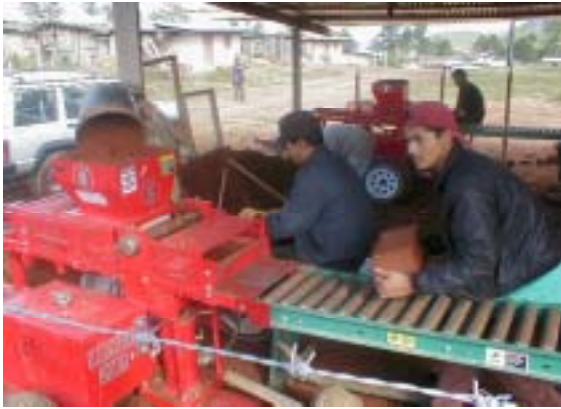
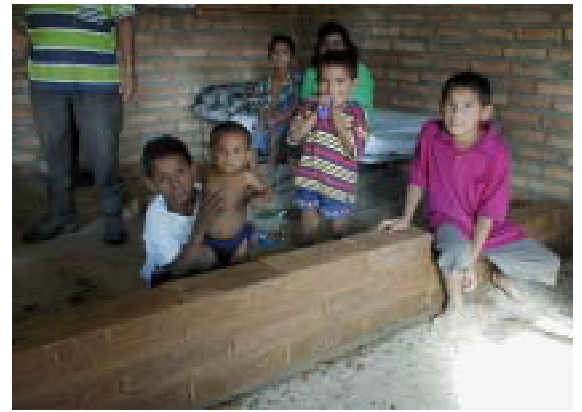
Figures 17-18. Left photo--Pressed earthen blocks roll off from one of 3 block machines for home construction in Humuya area; Right photo--Interior wall under construction with earthen blocks

Provision of three mobile earthen block machines greatly supported home building to replace destroyed, damaged, or vulnerable houses in the Humuya upper watershed. Three machines that press soil into adobe earthen blocks were donated by USDA to PAG to expand their Hurricane Mitch house reconstruction program. With an additional USDA grant of \$8,415, PAG provided locally trained operators to take the machines around to different communities for use in new home construction or existing home improvement. USDA also provided a diesel engine to PAG to rehabilitate an earthen block machine that had broken down.

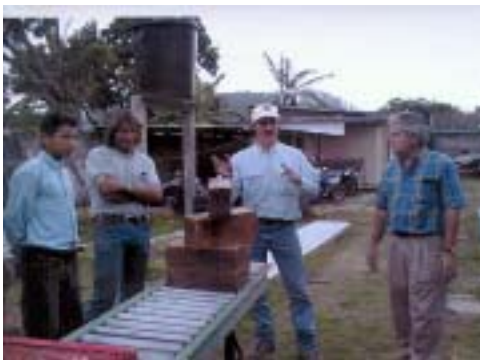
Figure 19. PAG staff and community members learn improved adobe home construction techniques during a USDA training session.

Expert training and consultation in earthen adobe home construction applied new techniques to improve sturdiness of the homes, reducing vulnerabilities to severe storms and earthquakes. USDA provided the services of a US expert in earthen adobe block home construction who provided training and consultation in building safer dwellings. Improved techniques included the use of a mud slurry as a mortar to make the walls much stronger, use of a continuous bond beam around the top of the walls, and use

of cement-stabilized blocks at the bottom of the exterior walls to avoid block weakening from water penetration. PAG staff and community members working on the home construction projects were the beneficiaries of this training and technology transfer.

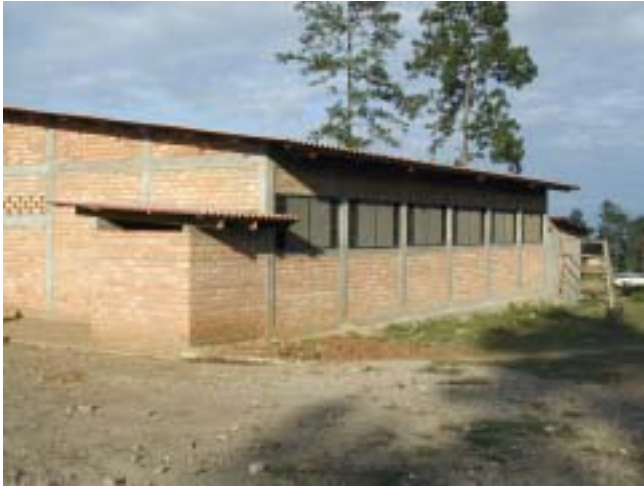
Figure 20. School/storm shelter at Brisas del Campo, Humuya Watershed.

Construction of school/storm shelter at Brisas del Campo improves the community. Brisas del Campo was one of the three communities where PAG constructed houses with USDA support for the addition of kitchen/latrine annexes. USDA provided \$22,709 in a grant to enable PAG to construct the school, under the provision that it function as a storm shelter as well. USDA also offered technical advice for improved construction methods.

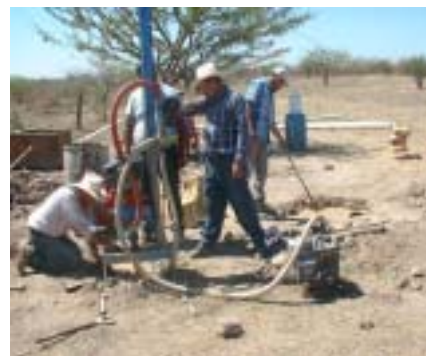
Technical assistance in dairy for 254 farmers in the Aguan and Choluteca watersheds, had a beneficial impact on 743 ha. of dairy agricultural land, and added \$714,000 in land value. The main losses to dairy farmers from Hurricane Mitch were in animals and infrastructure, including milking and feeding structures, fencing and irrigation systems. Many farms lost their access to water because the rivers and streams changed their courses. The damage exacerbated already existing problems of feed shortages, poor quality animals and pastures, and poor access to water for drinking.

Figure 21. Boring wells provides farmers with water

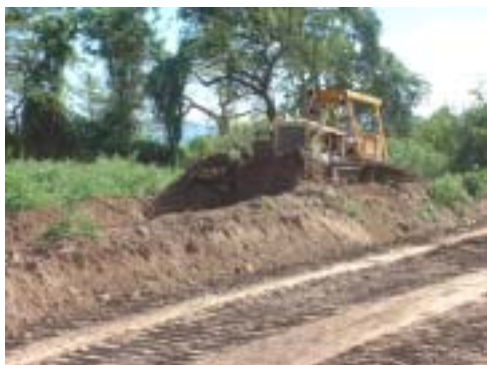
Figure 22. Land leveling makes damaged sugar cane fields usable again

Land reparations to Mitch-damaged sugar cane fields in Choluteca raised land values by \$1000/hectare or more. Flooded rivers deposited sediments over much of the sugar cane land in the lower Choluteca watershed. More than half of the fields were covered in a layer of sandy sediment, sometimes to a depth of more than a meter. USDA's rehabilitation included leveling the land and mixing in the sediments. Mixing in the newly deposited sediments was particularly beneficial because it lightened the normally heavy clay soils, resulting in a post-Mitch sugar cane crop with a very good yield. In the case of the very first farm reclaimed, the yield after rehabilitation was better than any the farmer had obtained before. In addition, USDA provided for the boring of shallow wells for irrigation on some farms. The increase in land value for the 277 ha. directly treated on this project has totaled \$347,000.

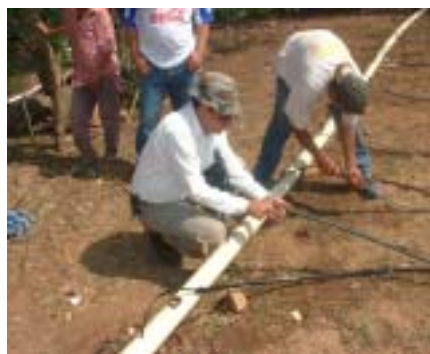
Figure 23. Irrigation assistance for Choluteca and Aguan lower watersheds.

Land reparations to Mitch-damaged vegetable fields in Choluteca and Aguan raised land values by an average of \$1300/hectare. In the case of high value vegetable crops, land was washed away and/or irrigation systems were destroyed. USDA collaborated with the U.S. Army of Corps of Engineers (also funded by USAID) on the design and development of gabion diversion dams and repair of a canal-based irrigation system. USDA also collaborated with Lifewater Foundation, a US-based NGO, in drilling low-cost wells for small irrigation systems.

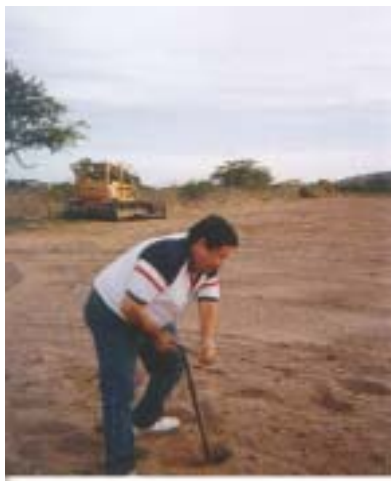
Figure 23. Soil sampling in a reclaimed sugar cane field
